# **Historic Building Assessment for the Belknap Mill**

**25 Beacon Street East, Laconia, NH 03246**

Mae H. Williams, Preservation Consultant & Misiaszek Turpin pllc

June 2017

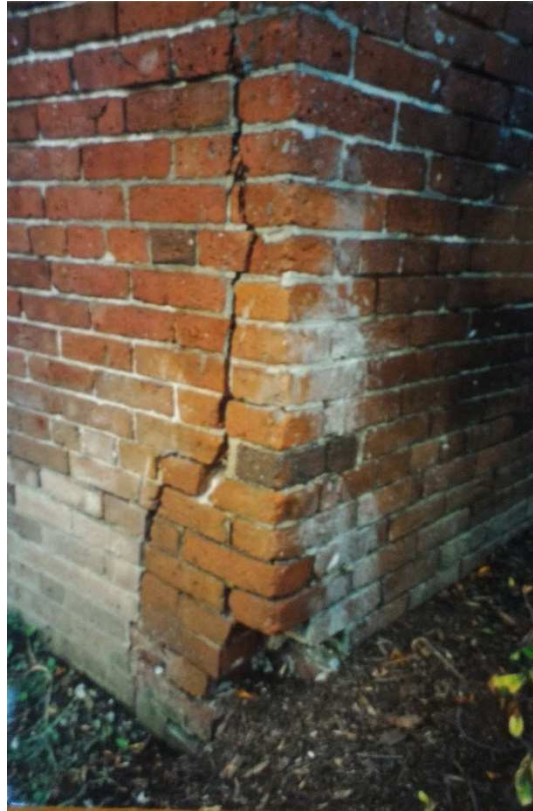
The Belknap Mill suffered some serious damage to its historic masonry walls in 2000. In January, a sprinkler pipe burst, sending water out of the side walls of the mill and eroding the porous lime mortar (**Figure 17**). Most of the damage was confined to the north and east facades. In February, the local newspaper reported that the Society’s insurance would pay for all but \$10-\$15,000 of water damage.

**Figure 17: Masonry damage to Belknap Mill following January 2000.**

In April of 2001, the Belknap Mill Society applied for their first Land and Community Heritage Investment Program (LCHIP) grant to repair and repoint the four exterior masonry walls of the Belknap Mill. They asked for \$75,000 from LCHIP for what was projected to be a \$188,000 mortar restoration project. The project was funded and in the summer of 2002 John Wastrom was employed to head up the project with Bonnette, Page and Stone, Contractors and State Architectural Historian, James Garvin overseeing the project to ensure that it was done in compliance with the *Secretary of the Interior’s Standards*. Select repointing was to be done on all facades, especially around window openings. The grant specified that new mortar was to match the historic mortar joints in color, texture (sand grain size) and profile. All work was to be done manually with mortar joints cleaned out to at least  $\frac{3}{4}$ -1” deep prior to repointing. Initially, Wastrom suggested a mortar mix of 1 part lime, 1 part white Portland cement and 6 parts sand to “withstand New Hampshire’s acid rain without damaging the soft brick.”<sup>196</sup> Fearing that the resulting mortar would be too hard and not compatible with the historic fabric, Garvin had the contractor adjust this formula to 4 parts lime, 1 part grey Portland cement, and 11-15 parts sand.

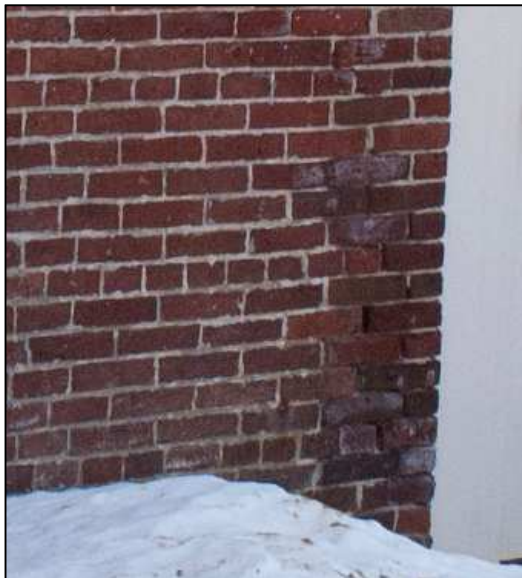
Figure 3: Mortar loss near the entrance door.

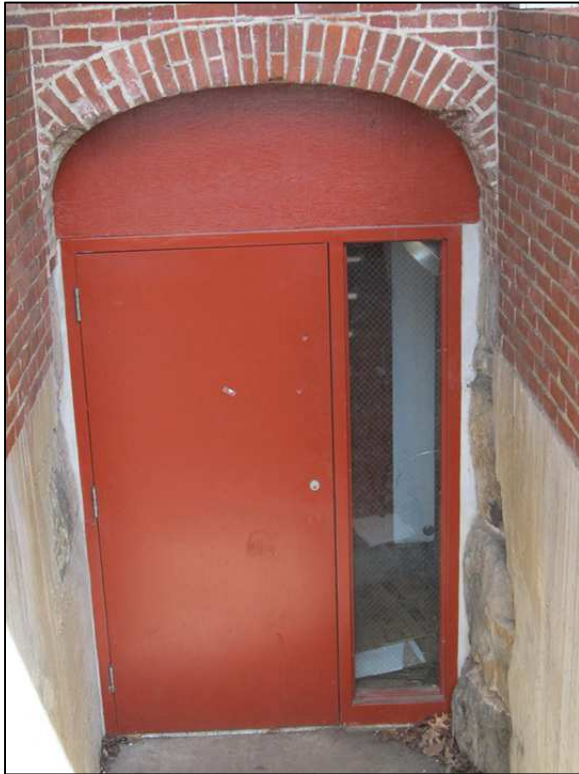
**Figure 7: Basement door with cracked sidelight**

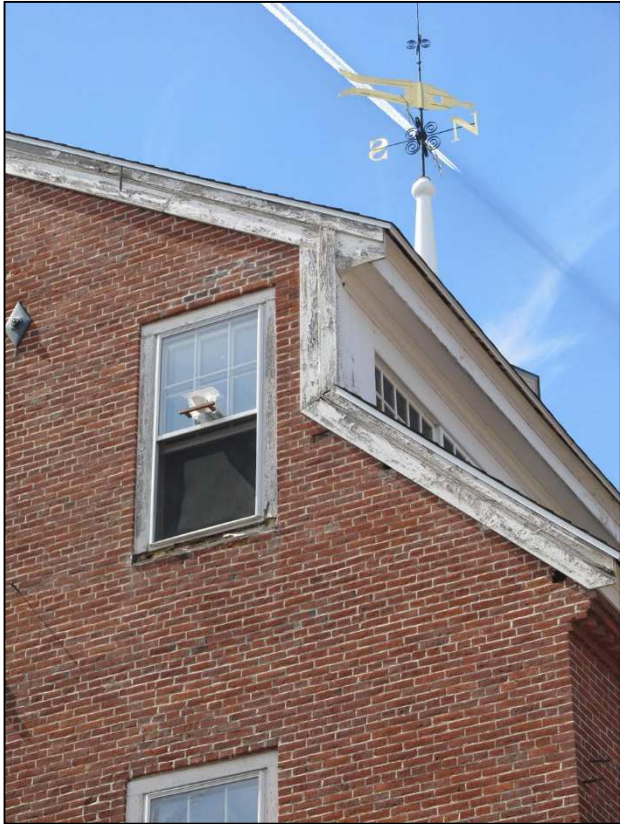
Figure 9: Peeling Paint at eaves/soffits

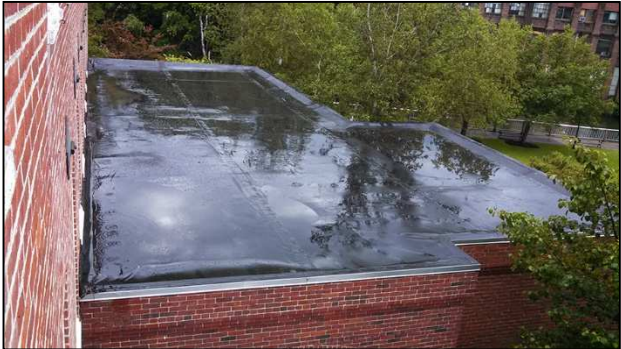
Figure 10: Looking down onto the Power House roof, with large areas of water pooling.

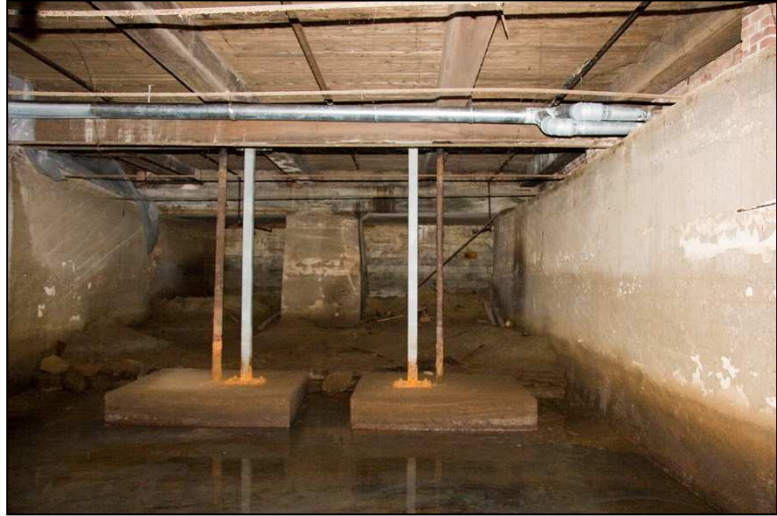
**Figure 11: Sluiceway beneath east portion of Belknap Mill**

has a full height basement space where the water from the canal originally occupied. Existing mechanical elements for the operation of the turbines and historic equipment are still located within this basement chamber (**Figure 11**). This space, and the sluiceway regularly maintain a couple inches of standing water, and are accessed via an access door in the floor of the eastern side of the Power House. At this entrance, a metal ladder is attached to the concrete wall, providing access into the space. This ladder has severe corrosion.

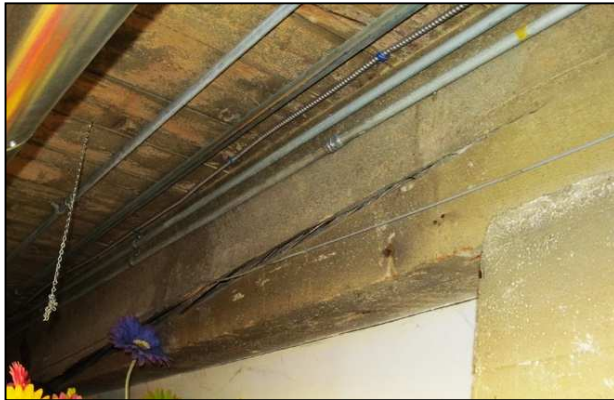
**Figure 12: Example of checking in beam**

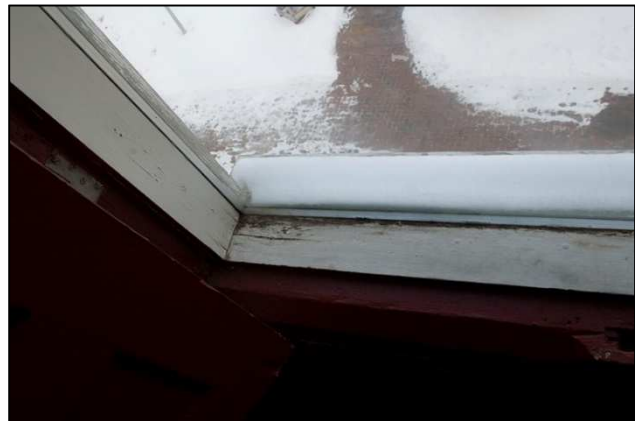
**Figure 25: Rotten sill, stair tower**
