# **Historic Building Assessment for the Belknap Mill**

**25 Beacon Street East, Laconia, NH 03246**

Mae H. Williams, Preservation Consultant & Misiaszek Turpin pllc

June 2017

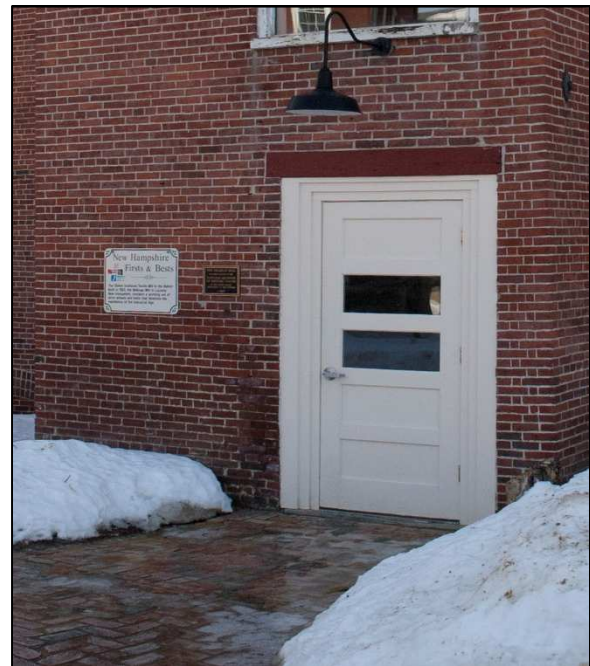
The main entrance to the Belknap Mill is located on the north side of the building directly off of Mill Street (now pedestrianized) within the central stair tower. Mill Street is composed of now uneven hand-laid bricks, and connects the Belknap and Busiel Mills with the footbridge crossing the river. At the front entrance to the Mill, the brick pathway slopes down and creates a slight bowl at the foot of the door. This space quickly pools with water, and in the winter, becomes a solid patch of ice (**Figure 1**). Not only does this effect the individuals attempting to enter the building, but it is also slowly damaging the entrance door, surrounding brick walls and causing water to periodically seep into the stair tower entrance space.

Figure 1: Main entrance to Belknap Mill

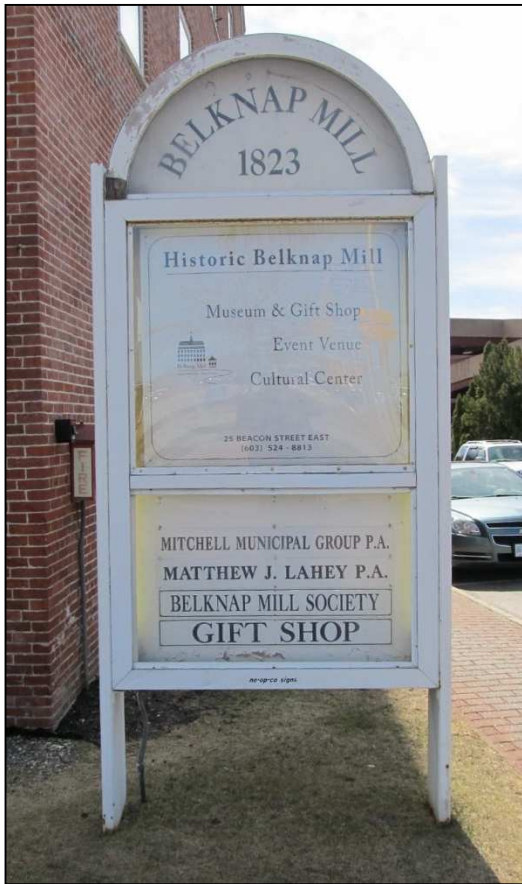
Figure 2: Belknap Mill sign.

the Power House, a black linear sign is located with gold lettering depicting the building's name, is in fair condition. The next sign is to the northeast of the stair tower. It has two large granite legs that puncture into the ground and support a solid wood sign connected with wrought iron chains. This sign was installed in 2012 and is in good condition. Lastly, a large, white painted, wooden sign with a central, plexiglass lettering case and arched top sits along the northwestern edge of the building directly off from the sidewalk and Beacon Street East. This sign is in poor condition having received no regular maintenance since its installation (**Figure 2**).

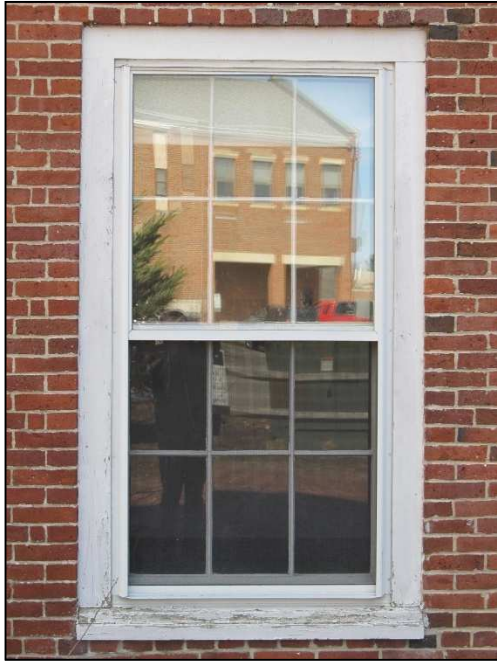
Figure 4: Typical 6/6 wood window.

The character-defining fenestration pattern remains in great condition on all four sides of the building. The 1970s replacement 6/6 wooden double-hung windows are in poor to fair condition, as many of them are experiencing deteriorating putty and poor weather sealant. Many of these windows have exterior aluminum storm windows that are not properly performing in energy efficiency and in operation, due to the age of the units and minimal maintenance efforts. (Figure 4). All of the window trim is in very poor condition as most of the paint has peeled off, causing some of the wood to begin rotting and/or splitting. This degradation is most notably seen along the historic clerestory windows of the fourth floor, whose linear façade is entirely wood. These clerestory windows, which are original to the building's construction, are in extremely poor condition with glazed panels very near to falling out (Figure 5). Additionally, window sills around the building have begun rotting, most notably on the east side of the fourth floor, where several have fallen off completely (Figure 9).

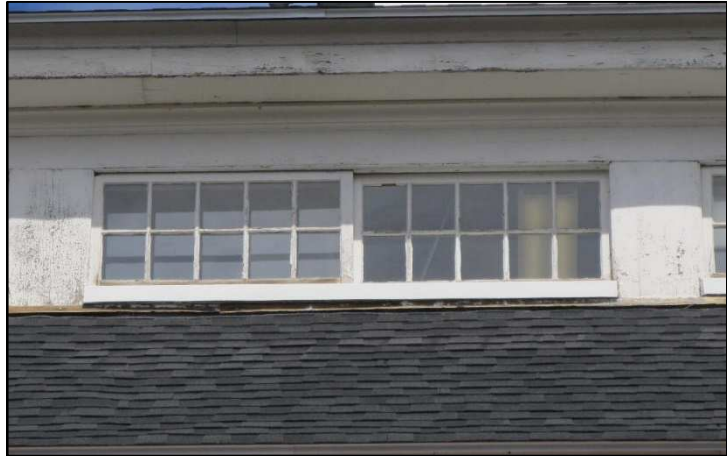
Figure 5: Typical clerestory window.

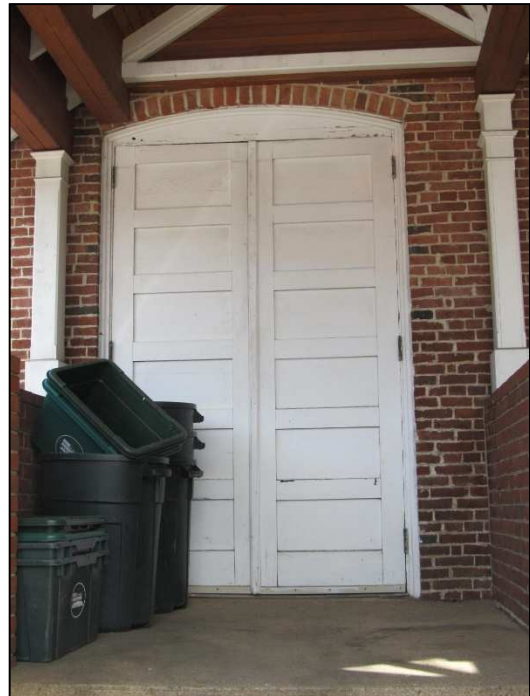
Figure 6: Southwest door to Belknap Mill.

its lower portion, as there is no kickplate or door stop, and from pooling water from the brick entry path. The final egress from the building is the horizontally paneled, wooden double door in the southwest corner of the main level. This is in fair condition with paint that is beginning to fail (**Figure 6**). The recent energy audit, performed by Resilient Buildings Group, found the insulation and weather-stripping of this door to be insufficient (**Appendix E: EEM #88**)

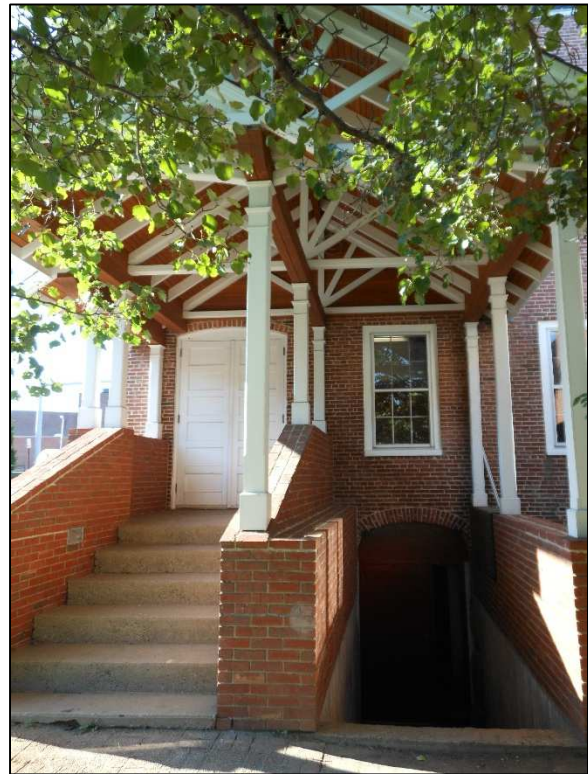
There is an exterior entrance to the basement of the Belknap Mill at the southwest corner of the building, to the east of the horizontally paneled wooden double doors. This basement access is reached down a set of poured concrete stairs. The door to the basement is metal and has a single reinforced side-light window. The glass is cracked across the center of the window (**Figure 7**). Both this basement door and the wooden double-door are located under a portico. This portico addition was constructed in 2005 to protect both doors from the elements. As part of this construction, some new partial height brick walls were constructed, encasing the concrete stairs and providing a base to the white painted columns supporting the roof. The roof is additionally structured with white painted, wooden trusses. The ceiling is bead-board stained to match the horizontal structural components (**Figure 8**).

**Figure 8: Portico at southwest corner of Belknap Mill**

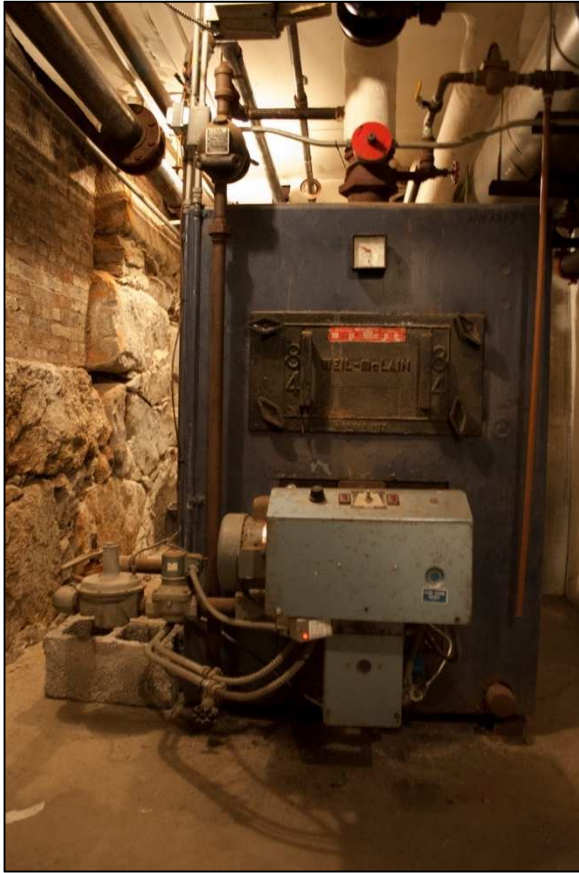
Figure 13: Belknap Mill boiler

In general, the mechanical system throughout the entire building has reached the end of its lifespan and requires extensive replacement. Current equipment does not meet regulations for energy efficiency, nor is it financially sustainable, as parts have become extremely limited (**Figure 13**). The existing boiler was installed in 1968 and is a natural gas fired boiler. The unit is in poor condition, with spare replacement parts becoming rare and costly and does not meet current efficiency standards

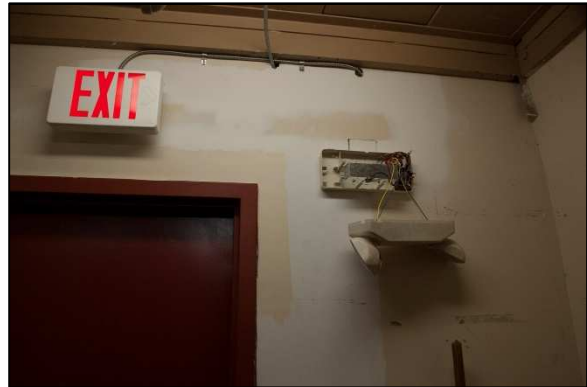
**Figure 14: Emergency lighting**

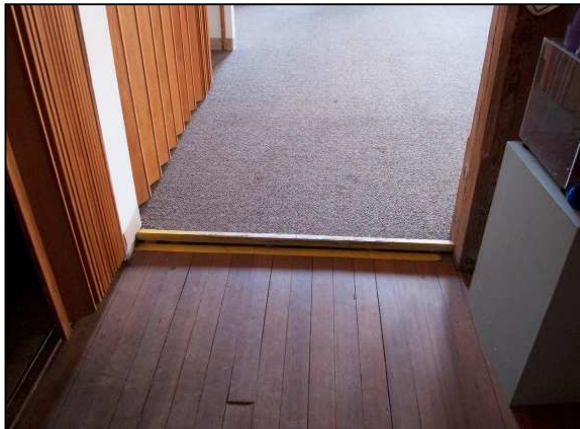
**Figure 15: Transition of floor from gallery to knitting room, first floor Belknap Mill**

During the 1973 renovations, efforts were taken to preserve the historic hardwood floor on this level. To achieve this, a “floating” or raised floor of approximately 1½” was constructed across the entire main level except for the southeast corner, where today, a knitting exhibit is located (**Figure 15**). Within this southeast corner, the historic hardwood floors are still visible and showcase limited damage. It is believed that the remainder of the original wood floor was left in place and sensitively covered over with the floating floor, which is all carpeted, minus the tile in the lobby and the restrooms. These modern floor surfaces are in poor to fair condition with ground-in stains, fraying, and some cracking.

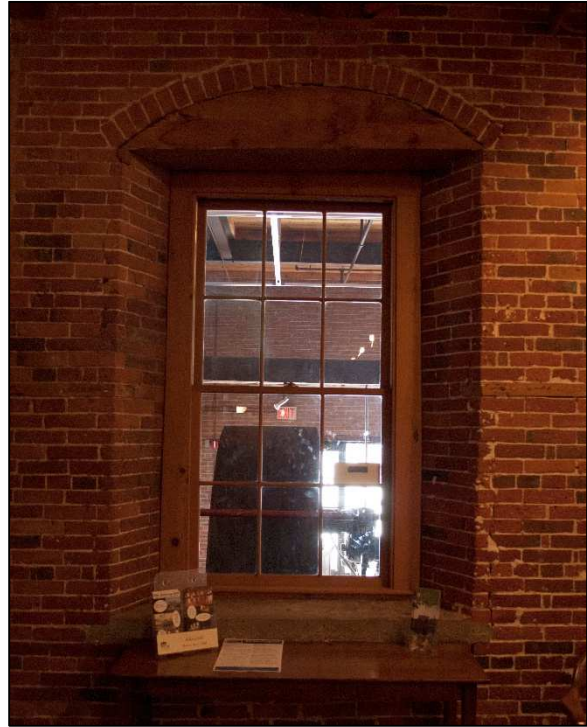
Each window unit is left unpainted on the interior – compared to its exterior, white painted face. Above each unit is a wooden, semi-circle header, that are generally in fair condition; however, many have substantial aging and splitting. Similarly, most windows have a thick wooden interior sill; however, there are a few sills throughout the building that have been replaced with poured concrete sills. All of the wooden sills have splitting, in some cases, extensive splits (**Figure 16**).

Figure 16: Typical interior window

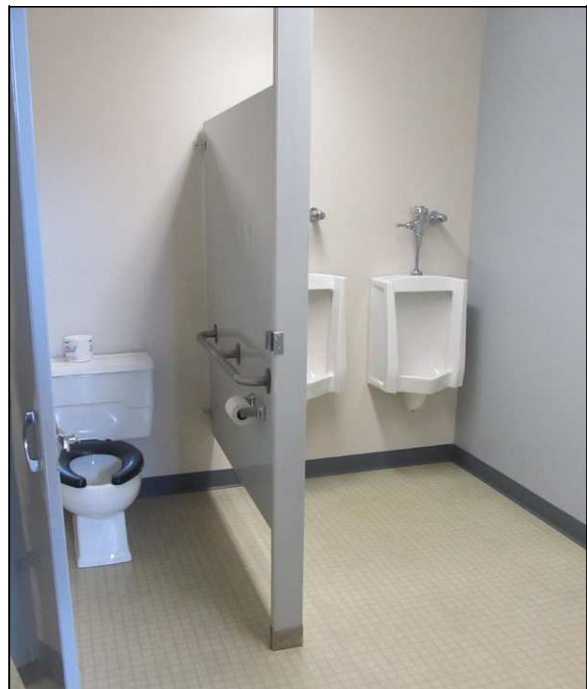
Both the men's and women's restrooms are in fair condition. Each have tiled floors, aged partition and divider walls, and plumbing and light fixtures that were installed during the 1970s renovations and are not energy efficient. The plumbing system is also in need of repair in both spaces. Additionally, neither restroom complies with accessibility code required for all buildings with assembly occupancy and public use (**Figure 17**).

Figure 17: First floor men's room

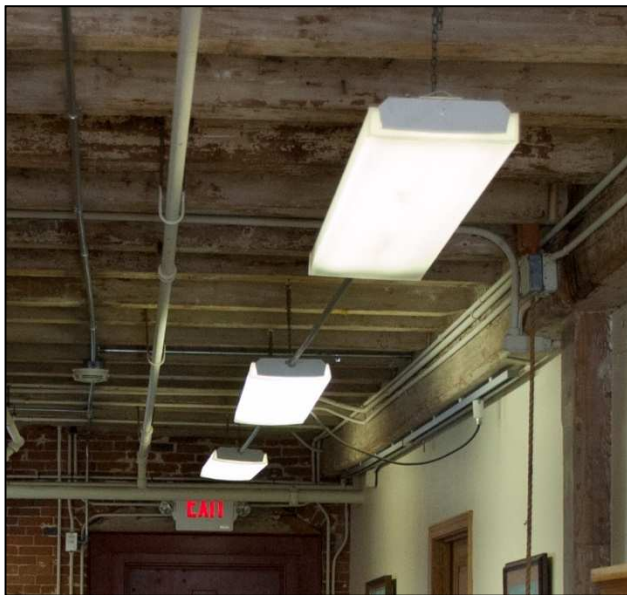
**Figure 19: The hall lighting on the second floor is typical of the Belknap Mill**

to all fixtures would be beneficial for energy efficiency and performance. Typically, public spaces are lit by inefficient overhead fluorescent lighting that dates from the 1970s (**Figure 19**). The second floor of the building has the same mechanical system arrangement as the first floor, with fin tube radiant heating along the brick exterior walls and an air conditioning unit with a refrigerant component located outside. This system is also nearing the end of its useful life.

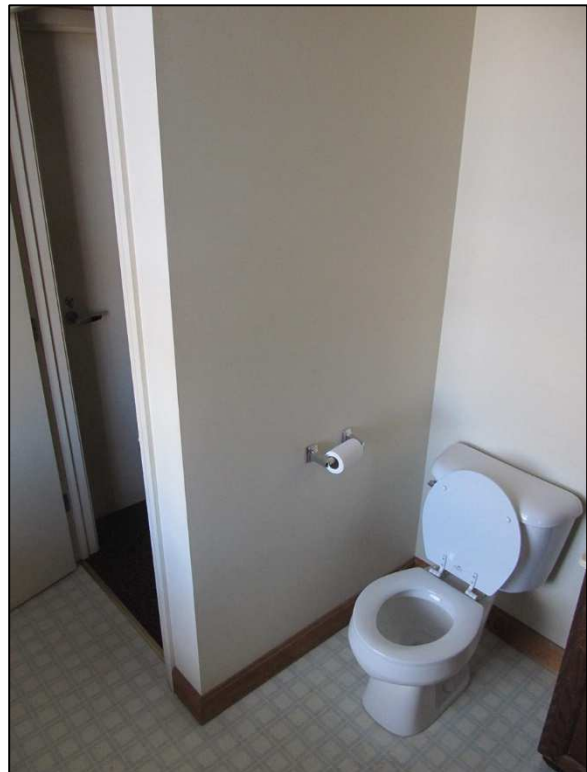
Besides the main brick exterior walls, all interior walls are of gypsum board with wooden doors and are in good condition. The restroom is in good condition; however, it is not compliant with accessibility regulations, as the entrance is too tight to navigate through (**Figure 18**). The layout of this floor has been addressed since the 1970's renovations when tenants moved in. Carpeting has been laid across the entire floor except in restrooms. This carpet is in good condition.

**Figure 18: Narrow entrance to second floor restroom**

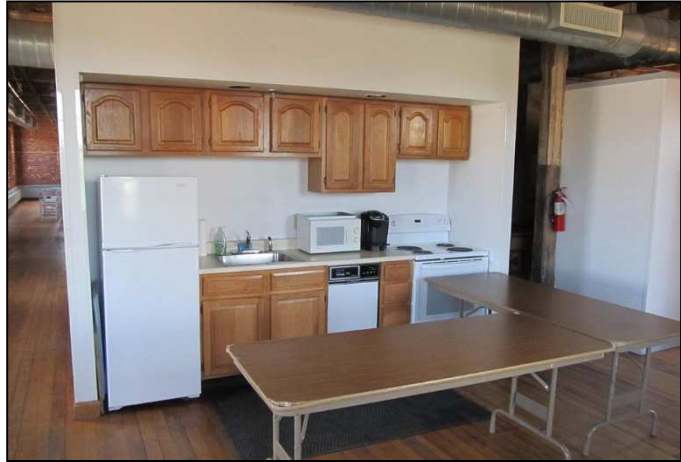
**Figure 20: Kitchenette, 3rd Floor Belknap Mill**

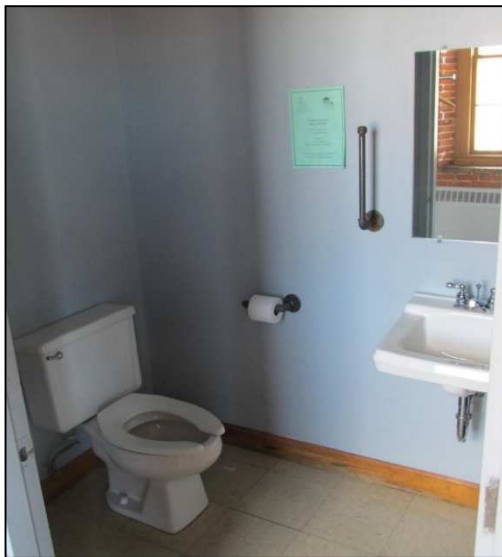
**Figure 21: 3rd floor bathroom**

Both the men's and women's restrooms are in fair condition. Each have tiled floors and plumbing and light fixtures that were installed during the 1970s renovations and are not energy or water efficient. The plumbing system is also in need of repair in both spaces. Additionally, neither restroom complies with accessibility code, as there is inadequate turning space within the restroom and the fixtures do not have the proper hardware. Furthermore, neither restroom has the correct number of fixtures for assembly occupancy building classifications, as mandated by Life and Safety code (**Figure 21**).

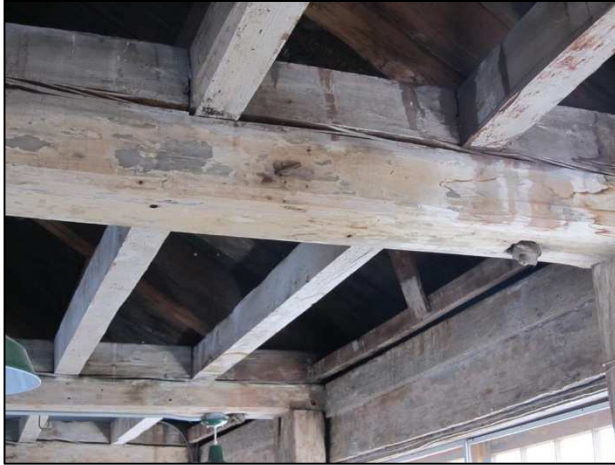
Figure 22: Checked beam, 4th floor

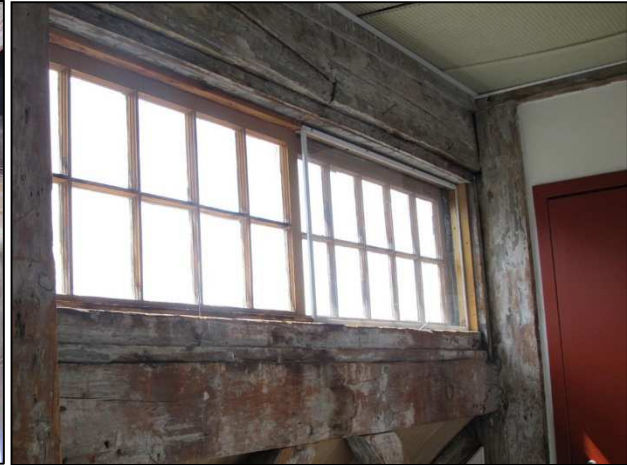
Figure 23: Clerestory window

The columns supporting the roof are located alongside the clerestory windows and are in good condition, still showcasing the original white-wash paint treatment, with only minor areas of splitting. The clerestory windows, which are original to the building, are in poor condition, with the putty and weather-stripping in extreme decay, no longer securely holding the glazing (**Figure 23**). In general, this entire space is not energy efficient, as there is massive heat loss and gain through the uninsulated roof structure and single-pane glazing, which is experienced year-round. This area was highlighted as a much-needed area for improvement by the March 31, 2017 Resilient Buildings Group "Belknap Mill Society Comprehensive Energy Improvement Plan for the Future (**Appendix E**). The west side of the 4<sup>th</sup> floor is entirely uninsulated, whereas the east side has some rigid foam board insulation and fiberglass batts, both of which are underperforming due to improper sealing and compression.

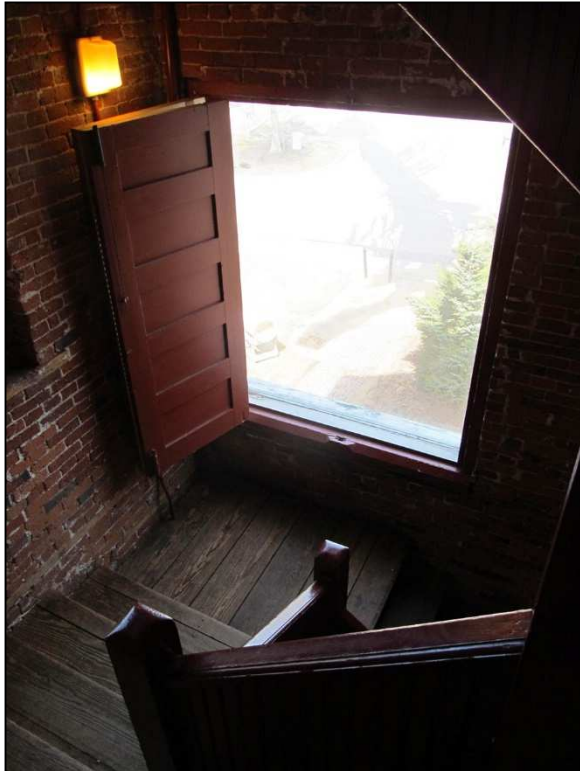
**Figure 24: Stair tower window**

photographs. In the 1970s, double-doors were installed at these locations to replicate the most recent generation of doors (**Figure 24**). They are in fair condition but express some damages and alterations; at the upper level set, they have been hinged together and fold to the west side of the opening. At both openings, the sills are rotting and the paint is heavily chipped (**Figure 25**). The west wall of the tower has a 6/6 double-hung window located at each floor level. These 1970s windows are in similar condition to the rest of the building's windows.

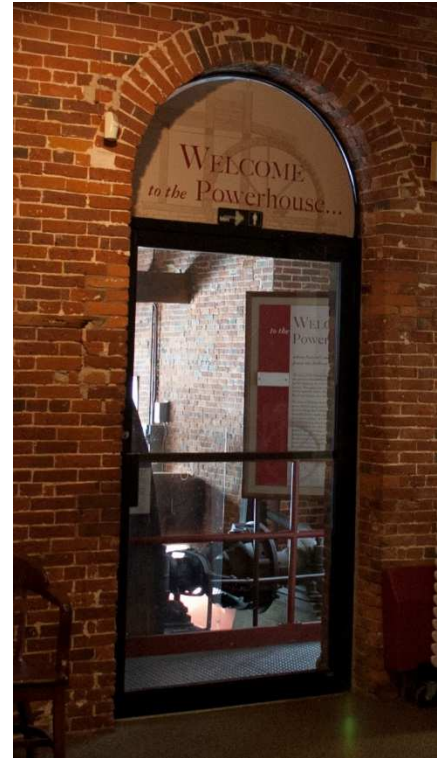
An arched brick opening connects the reception and exhibit space into the Power House, through a modern, metal storefront door added during the 1973 renovations (**Figure 26**). This arched opening appears to be original to the building; however, it did not always provide access into the Power House (as late as 1948, it was sealed). The entire original opening was reopened during the 1970s renovations, with no apparent alterations to the form of the opening, and is in good condition.

**Figure 26: Door between Belknap Mill and Power House**
